DELAWARE RIVER BASIN
DOCTORS CREEK, MONMOUTH COUNTY
NEW JERSEY

IMLAYSTOWN LAKE DAM

NJ00218

PHASE 1 INSPECTION REPORT NATIONAL DAM SAFETY PROGRAM

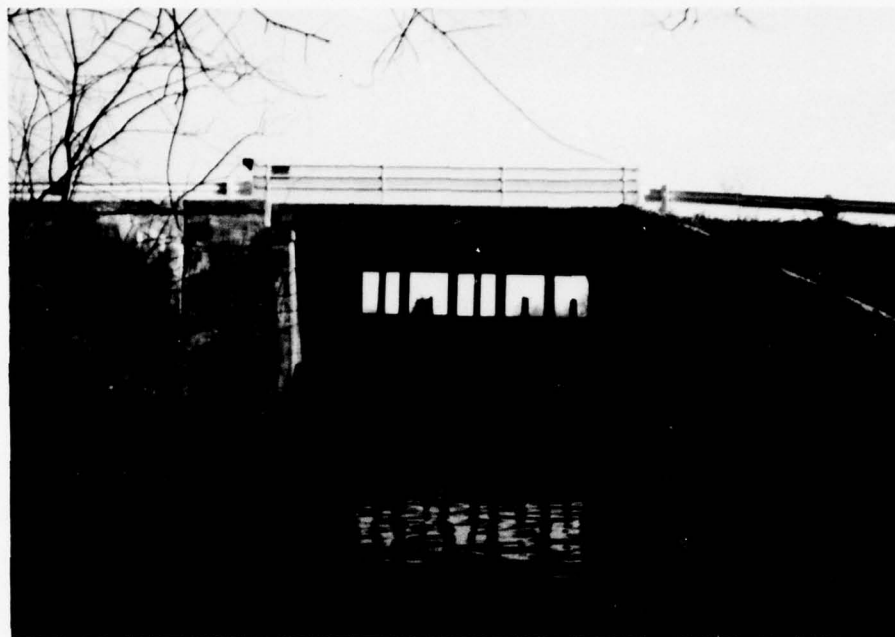
PHOTO 1

PRIMARY SPILLWAY - DOWNSTREAM VIEW.
BRIDGE OVER SPILLWAY DISCHARGE CHANNEL.

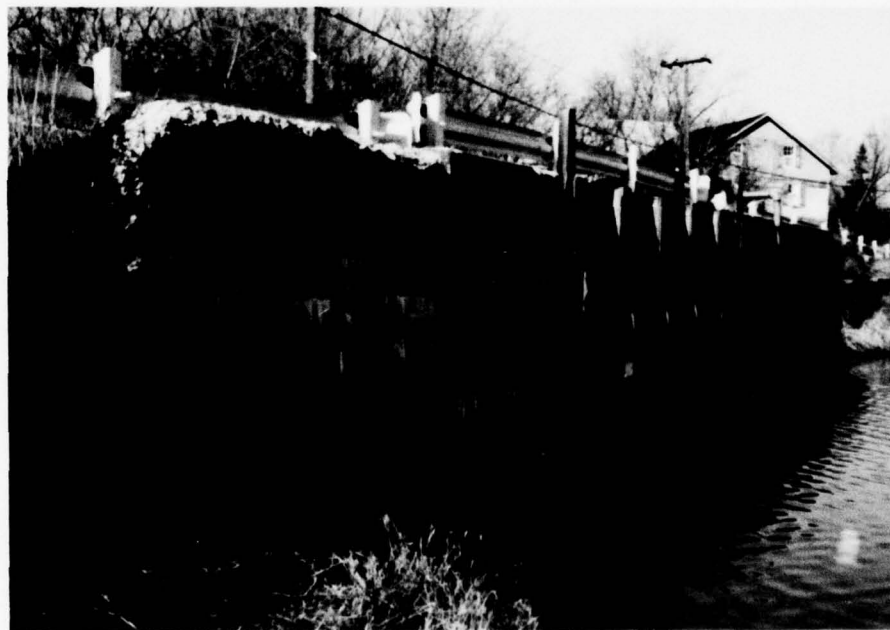
PHOTO 2

The crest of the spillway, formed by the tops of the slide gates, was submerged by overflow at the time of inspection. The gates could not be directly observed, although they appeared uniformly aligned. The timber supports for the gates appeared to be in satisfactory condition. Three of the five gate lifting stems were broken off rendering those gates inoperable. Neither of the two remaining intact gates was operated at the time of inspection.

PRIMARY SPILLWAY - UPSTREAM VIEW

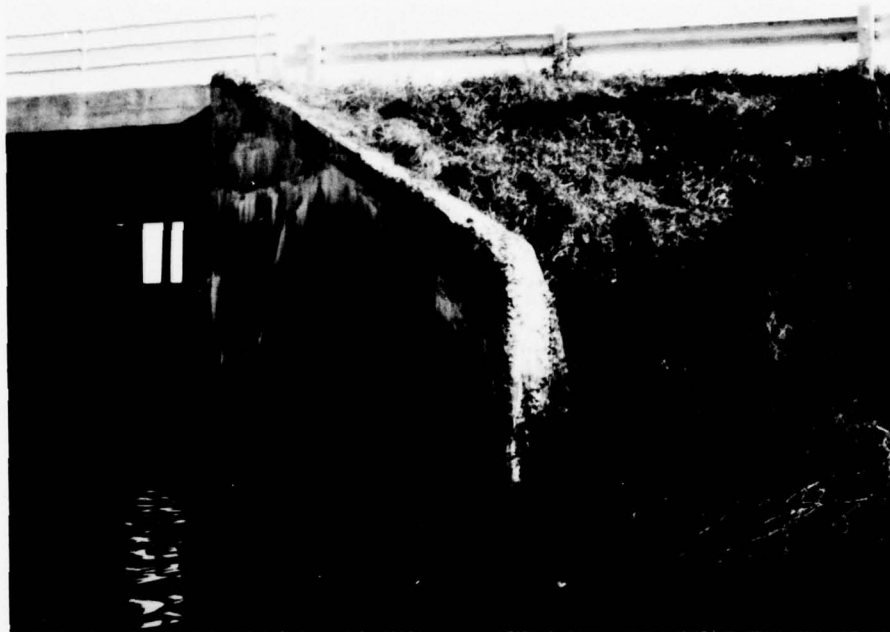
PHOTO 3

Although the bridge appeared to be structurally stable, all concrete surfaces were in a deteriorated condition - some surfaces severely so. Cracks and spalls were noted in the abutments, wingwalls, bridge beams and decking. Some leaching of concrete was observed at cracks and joints. Deterioration was generally most severe in the area of water line fluctuations and tops and sides of wingwalls.

SPALLED CONCRETE IN DOWNSTREAM WINGWALL
OF BRIDGE

Although the bridge is considered to be stable at present, the concrete is severely deteriorated. The bridge, therefore, should be reconstructed in the future. It is recommended that the owner consider, for purposes of economy, replacing the bridge at the same time that remedial work is done in connection with the principal spillway and embankment.

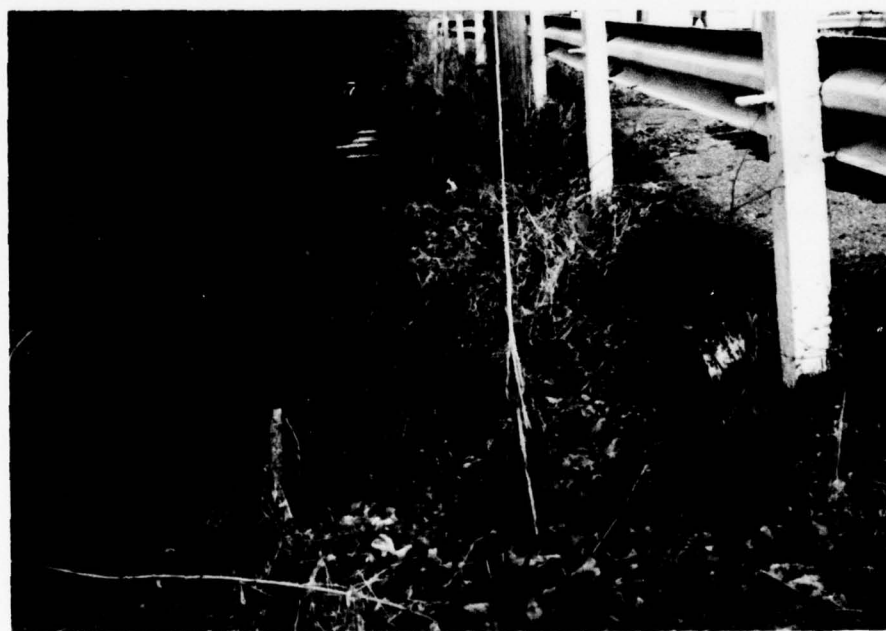
PHOTO 4

The embankment appeared, at the time of inspection, to exhibit significant structural distress on portions of its downstream side. Cracks in the road pavement along the downstream side and considerable deterioration of the masonry wall along part of the downstream face of embankment were observed. In addition, some settlement of the roadway on the downstream side of the dam was noted.

MOVEMENT IN DOWNSTREAM FACE OF EMBANKMENT

The embankment is considerably deteriorated by erosion on the upstream side and cracking and settlement on the downstream side. To correct this condition, a detailed design for a complete regrading of the embankment should be prepared very soon by a qualified professional engineer. The design should include an investigation of the structural stability of the former mill building which comprises a section of the dam. The embankment should then be regraded in accordance with the design immediately following its approval.

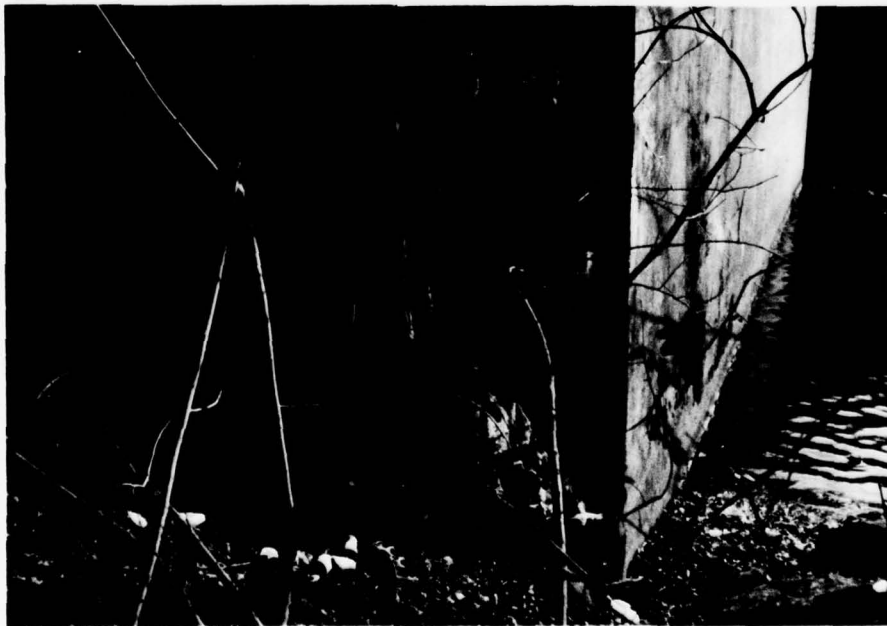
PHOTO 6

JUNCTION BETWEEN STONE WALL AND WINGWALL OF BRIDGE

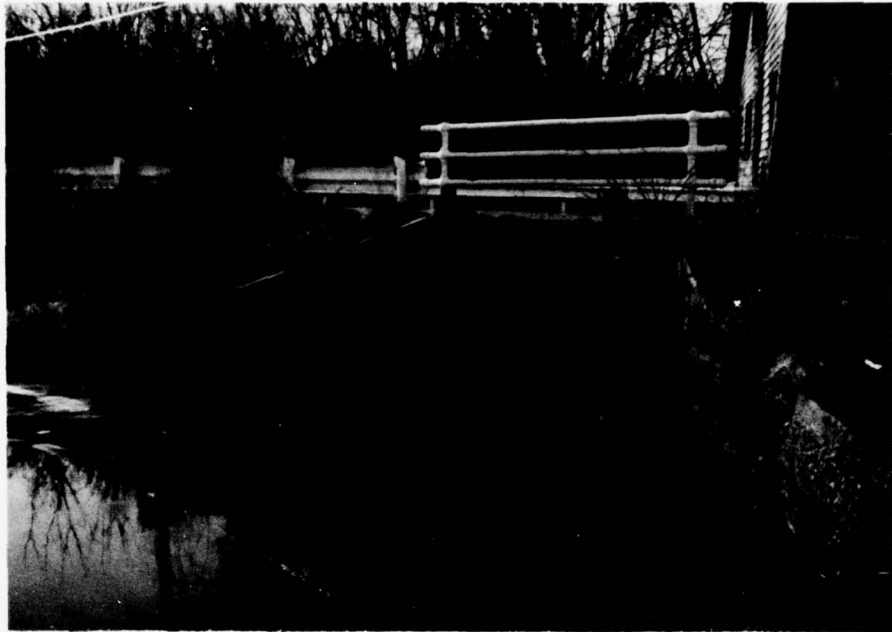
The intake to the secondary spillway discharge culvert was blocked by timber sheeting and a timber trash rack at the time of inspection. Therefore, the condition of the culvert could not be observed. However, concrete surfaces of the culvert headwall appeared to be in satisfactory condition. The timber flow barrier fitted at the intake to the culvert was leaking at the time of inspection and appeared unable to withstand hydrostatic pressures associated with water levels significantly higher than the roadway (elevation 50.0). Thus, the sheeting could fail under severe flooding conditions.

PHOTO 7
SECONDARY SPILLWAY

In addition to the measures outlined above, it is recommended that the owner, in the near future, reconstruct the flow barrier at the secondary spillway in order to provide a structurally adequate barrier.

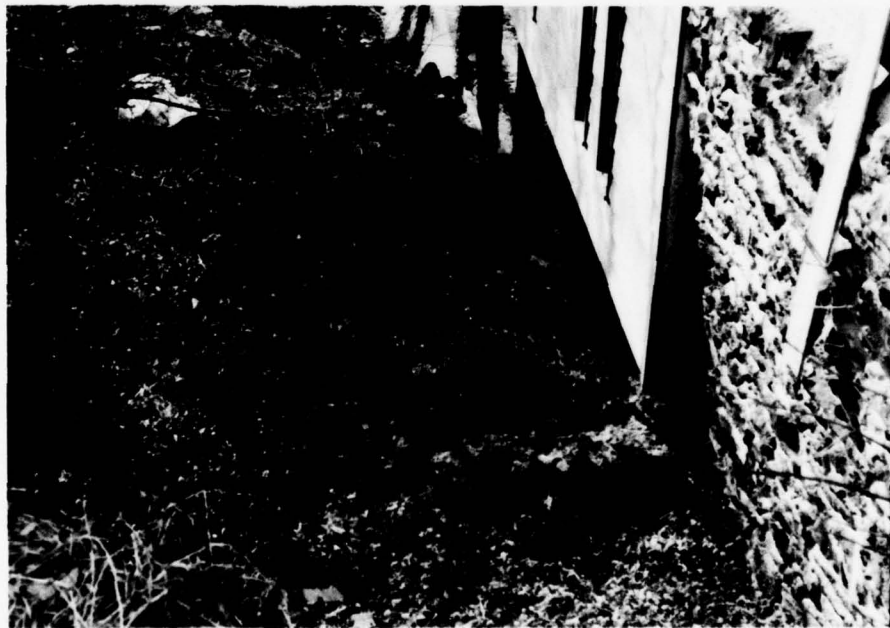
A point of seepage was observed downstream of the downstream toe of the dam and adjacent to the former mill building. Discharging in the form of a slight trickle, the seepage flows into the mill race beneath the building.

An accurate determination of the severity of the seepage depends on several factors, one of which is periodic observation. The severity of the seepage noted at Imlaystown Lake Dam cannot be precisely determined at the present time.

PHOTO 8
SEEPAGE AT TOE OF DAM UNDER FORMER MILL

Additional evaluation is considered necessary in order to assess the effect of the observed seepage on the structural integrity of the dam. The evaluation should be based on monitoring of seepage as outlined in paragraph 7.2.c.

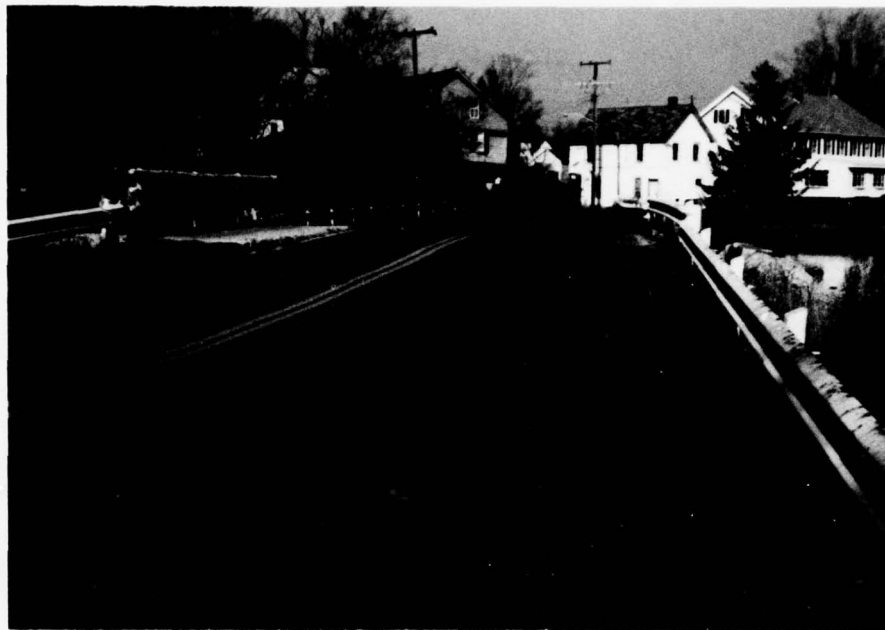
PHOTO 9

Adjacent to and on the west side of the paved road on the embankment crest, is located a bituminous sidewalk in which cracks have formed. The cracks are parallel to the dam and indicate possible shearing of the embankment.

PAVED ROAD ON CREST OF DAM
